PLAN OF ACTION
FOR
AYERS ROAD OVER COLD BROOK
BIN 2207390

TOWN OF HOMER

JUNE 2024

**New York State Department of Transportation
Plan of Action for Scour Critical Bridges**

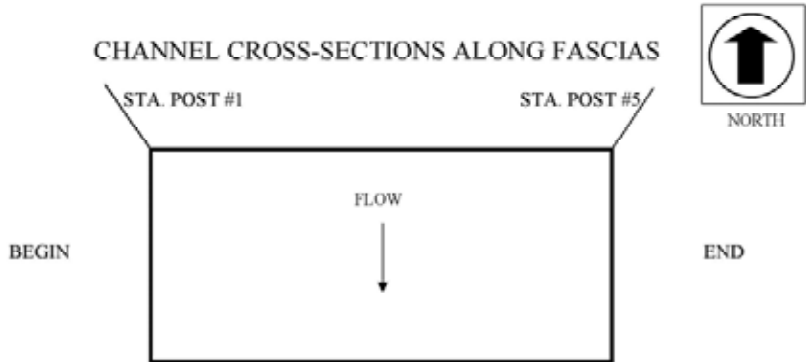
Sketch Number: 2

CHANNEL CROSS-SECTIONS ALONG FASCIAS

REFERENCE	YEAR	NOTES	
<p>DATUM: TOP OF PARAPET</p>	2013	Locations proceed from beginning to end as indicated in the columns below. Readings changed to each post referencing the top of timber parapet. Rail ht to top of deck = 3.04'. No drop readings taken in 2011 inspection.	
	2015	No significant changes	
	2017	Stream bed readings are changing, see BD226 for readings. Height of railing post 2.6'	
	2019	Minor fluctuations see BD226	
	2021	Increased degradation of the stream channel up to 1.6' at Post #2 on left and 1' at Post #4 on the right.	
	2023	Additional erosion along left and end right, new wall begin right

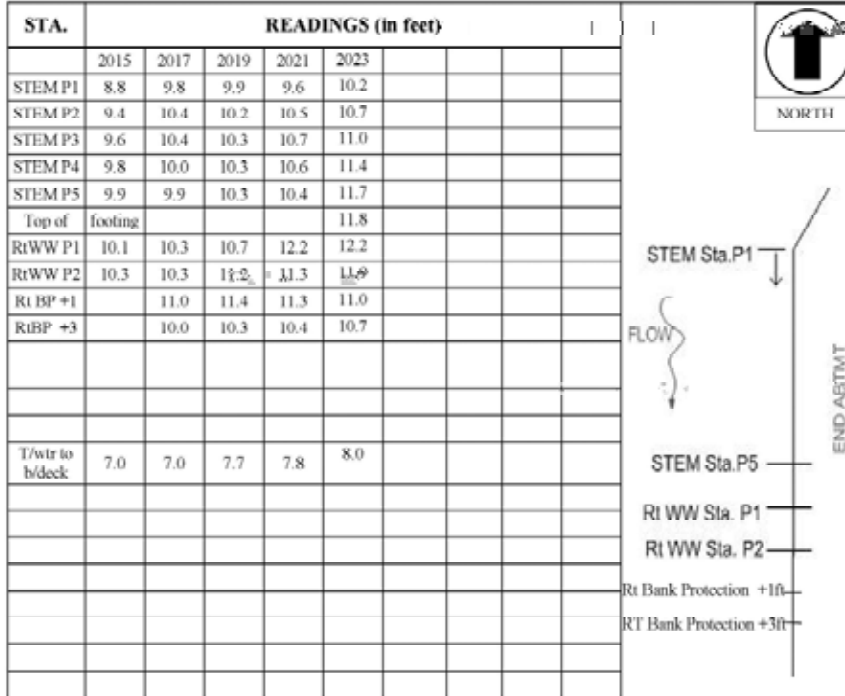
Sketch Number: 4

CHANNEL PROFILE ALONG END ABUTMENT

REFERENCE	YEAR	NOTES
		Datum: Bottom of deck to streambed
	2015	New readings, no undermining detected
	2019	Additional erosion, bank protection sloughing
	2021	Increased streambed erosion along end right wingwall up to 1.5' at Rt. WW Sta. P2.
	2023	Additional erosion no scour, top of concrete footer at 11.8ft deep at end right

Countermeasures	
Countermeasures Considered 1: Stone Scour Protection	Cost 1: \$30,000
Countermeasures Considered 2: Bridge Replacement	Cost 2: \$1,390,000
Countermeasures Recommended: It is recommended that heavy stone fill be placed along the east abutment where there is scouring to restore the streambed to the original elevation as shown on the record plans.	
Bridge Scheduled for Replacement? No	Estimated Letting Date: n/a

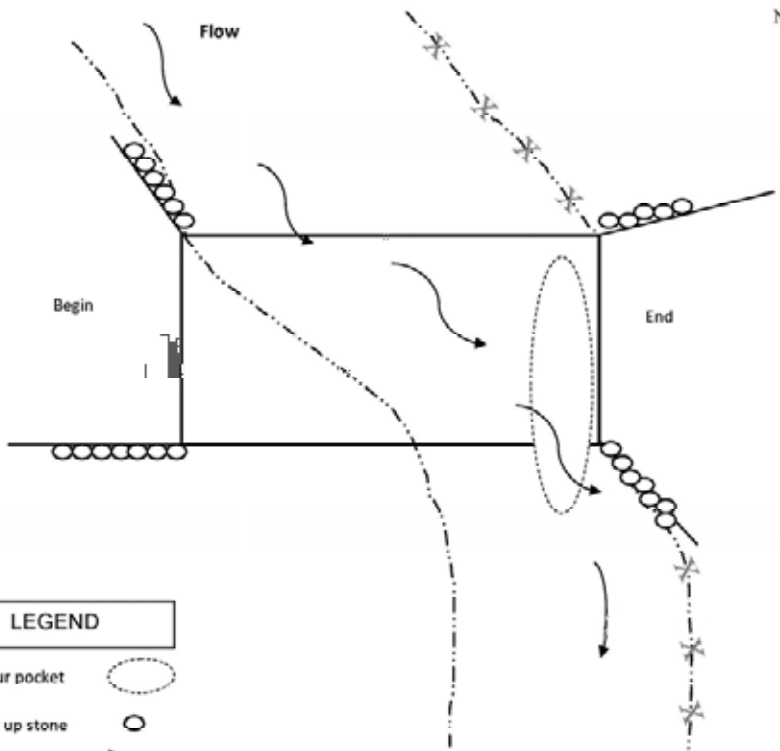
Sketch Number: 5

STREAM SKETCH
