**West Lake Art Conservation Center**

**Invoice**

Artist Name – Francis B. Carpenter  
Title – Portrait of Gideon Hobart  
Type – Oil on canvas  
Size – 32 ¼”h x 27 ½”w  
Framed – 27”h x 22”w  
Gallery ID – n/a

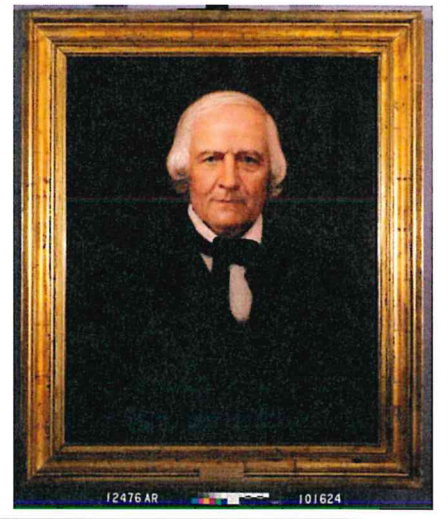
The painting is generally in very good condition structurally and aesthetically, with the exception of a light layer of dust and some minor abrasions at the perimeter of the composition. The artwork had been restored in 1996 by West Lake Conservators, Ltd., where it was lined with a BEVA 371 lining adhesive, fiberglass (Glassfabric) interleaf and G10 secondary support; this lining has remained in very good condition with the artwork remaining stable across the surface.

The gilt wood frame is generally in very good, stable condition structurally. The frame finish has retained luster in the gilding but also shows a developed patina, but the finish remains stable. There are minor abrasions at the outer corners that is moderately distracting.

1. Create written and photographic documentation before during and after the conservation treatment.
2. Remove the painting from the frame.
3. Vacuum the surface of the painting overall.
4. Apply varnish overall by spray.
5. Retouch areas of abrasion.
6. Install a protective backingboard on the reverse of the stretcher; Coroplast proposed.
7. Install a materials data label describing the materials used in treatment, along with retaining the previous materials data label describing the 1996 treatment.

1. Vacuum the surface of the frame overall.
2. Tone areas of frame abrasion and loss to match the original surface.
3. Install padding on the interior of the frame with 1/8" thick Volara foam to reduce abrasion between the painting and the frame.
4. Install the painting in the frame with new installation hardware; metal offset clips proposed.
5. Install new hanging wire.
6. Wrap artwork for storage.
