West Lake Art Conservation Center

Artist Name – Francis B. Carpenter
Title – Portrait of Electa Hobart
Type – Oil on canvas
Size – 32 ¼”h x 27 ½”w
Framed – 27”h x 22”w
Gallery ID – n/a

Examination

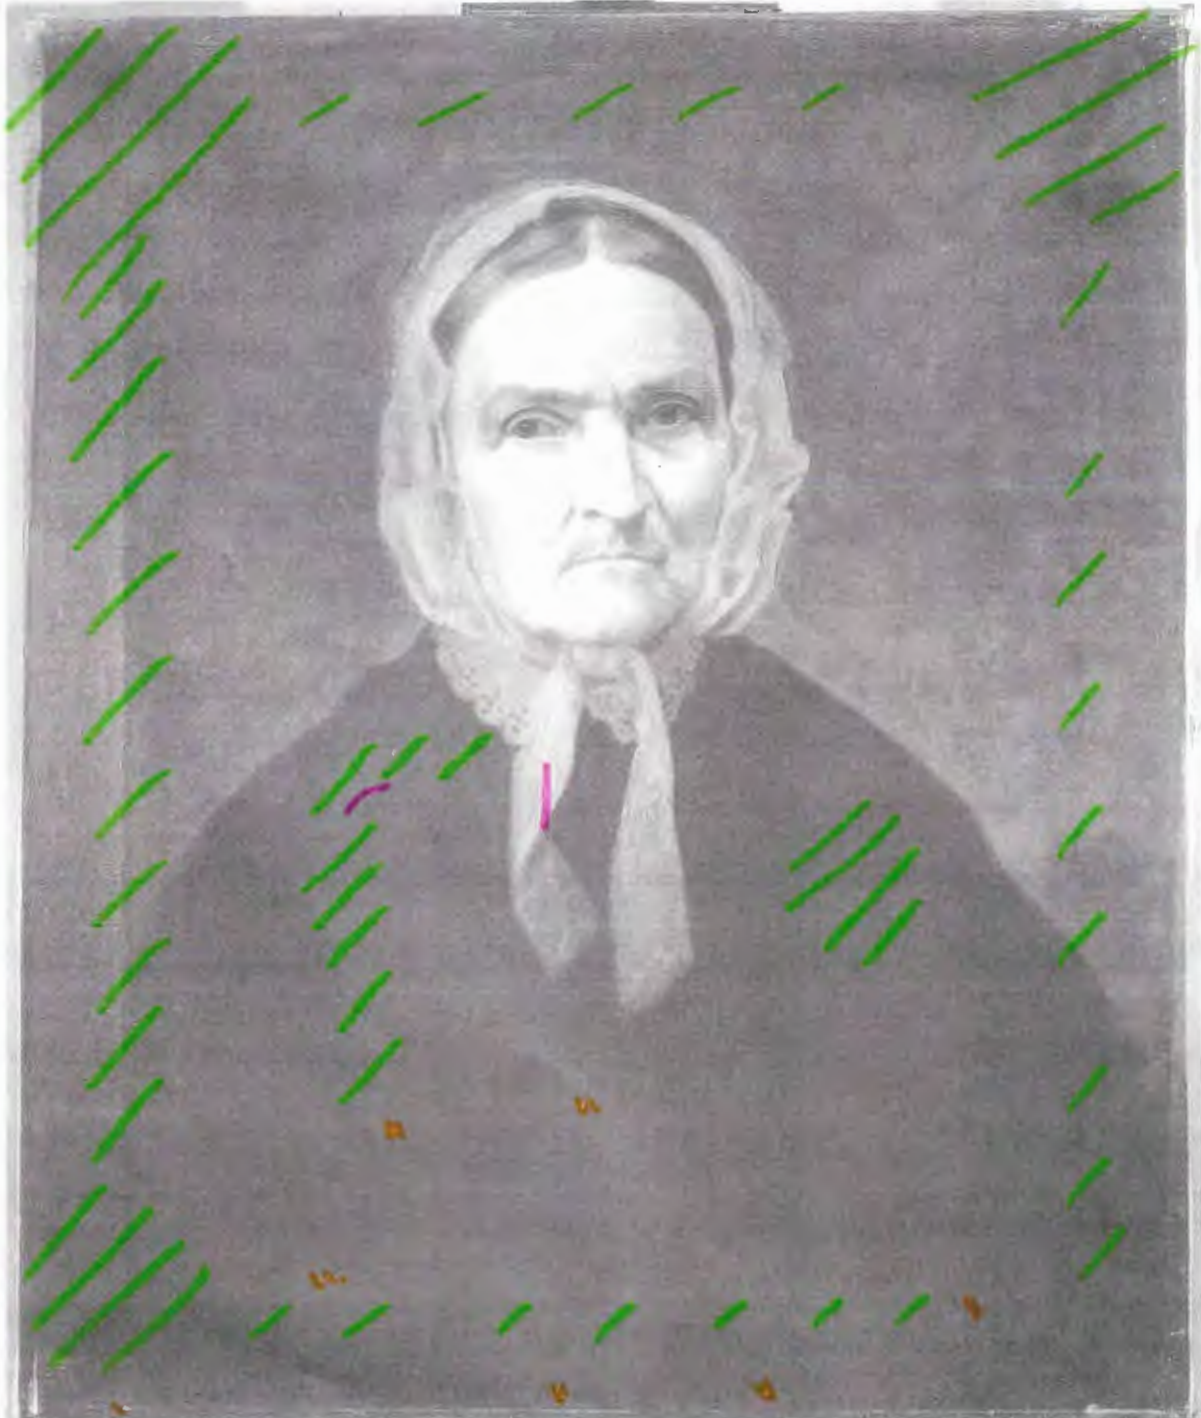
Support: The support is a medium-weight plain-wove canvas that appears to be linen. The support is generally in good, planar condition across the canvas with the exception some corner draw distortions at the top right, top left and bottom left corners, stretcher bar creases (distortions indicated in green in the condition diagram on page 5), and two small puncture tears, indicated in magenta on the condition diagram.

The gilt wood frame is generally in very good, stable condition structurally. The frame finish has retained luster in the gilding but also shows a developed patina, but the finish remains stable. There are minor abrasions at the outer corners that is moderately distracting.

Fig. 1. Condition Diagram, front, normal illumination; Orange areas indicate areas of loss to the finish of the frame.

1. Vacuum the surface of the frame, overall.
2. Tone areas of frame abrasion and loss to match the original surface.
3. Install padding on the interior of the frame with 1/8" thick Volara foam to reduce abrasion between the painting and the frame.
4. Install the painting in the frame with new installation hardware; metal offset clips proposed.
5. Install new hanging hardware.
6. Wrap artwork for storage.
